In order to properly remove the Denso 6kW resistance cabin heater from the 2012-2014 Toyota RAV4 EV that is equipped with JdeMO, the following procedures may be helpful:

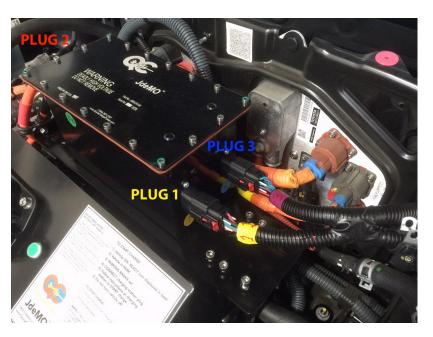
7. Remove the three low voltage communication plugs from the main JdeMO relay box assembly, labled "Plug 1", "Plug 2" and "Plug 3". These plugs contain both of the vehicle's high voltage interconnect circuits, therefore failure to follow these procedures in order may cause a "CHECK EV SYSTEM" fault in the vehicle. If you need instructions on the proper removal of these plugs, it can be found on the Molex website for an MX150 plug with locks.

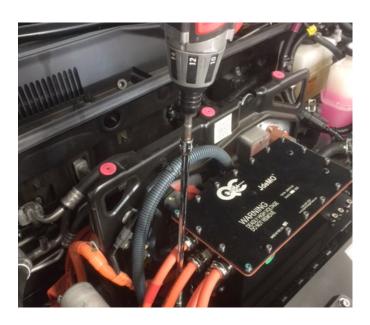
8. Remove the twelve stainless steel socket head M6 x 1.0 x 16mm bolts, six on each side, from the JdeMO top plate assembly. This will require a 5mm "Allen" style wrench. It may require a flex drive or "u-joint" drive to access the two bolts closest to the relay box on the left side.

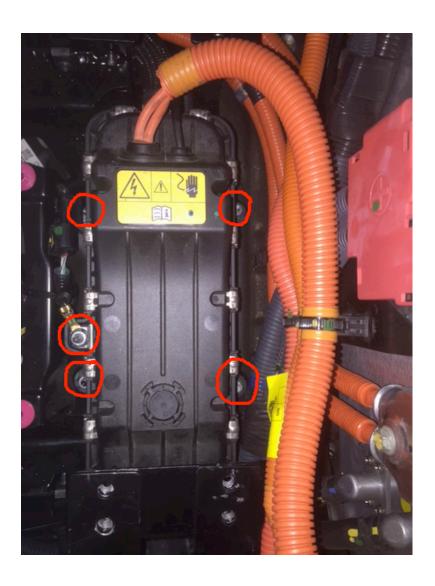
11. Remove the five M6 nuts (requires a 10mm hex head socket wrench), per Toyota service manual procedures and remove the Denso 6kW resistance cabin heater. It will be necessary to disconnect both the low and high voltage wiring harnesses, in addition to the heater hoses from either end of the unit (after draining the pink coolant per Toyota procedures). It will be helpful to slightly pull on the unit to the left during removal to clear the left legs of the JdeMO base plate assembly.

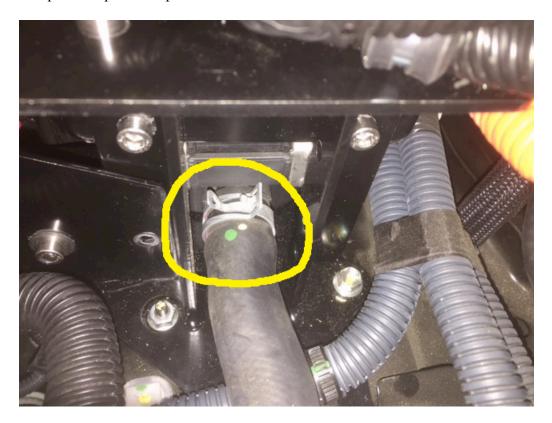
12. Upon reassembly with a new or remanufactured resistance cabin heater, ensure that the hose clamps face upward as pictured.
